HIGH PERFORMANCE NON-LUBRICATED COUPLING SERVICE LIFE AND FAILURE MODES

By James H. Paluh, Manager-Engineering, High Performance Products
Ameridrives International, December, 1997

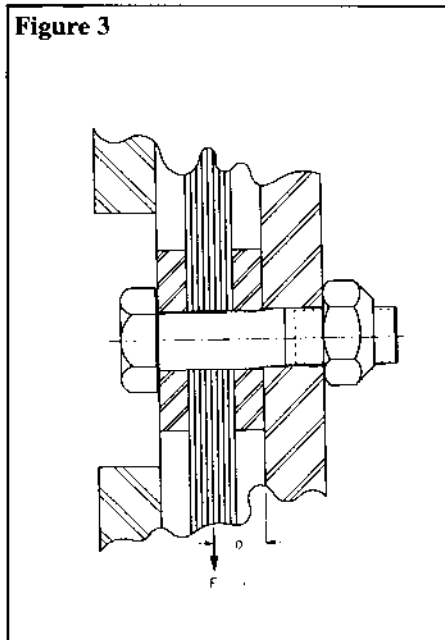
Figure 3

The design and proper installation of the disc coupling bolts is also critical since the inherent design of disc couplings require the bolts to transfer torque through shear and bending. The highest bolt stresses are in bending (**Figure 3**). This is in contrast to a typical flange to flange connection of a diaphragm coupling where torque subjects the bolts predominately to shear stresses. The proper tension of the disc coupling bolts not only decreases the bolt bending stress to acceptable levels, but affects the fretting and corrosion fatigue characteristics of the disc surface at the washer interface.
